PILOTNÝ PROJEKT ODSTRÁNENIA SYSTÉMOVEJ PORUCHY LODŽIÍ ZT

Posúdenie výskytu a návrh odstránenia systémovej poruchy predsadených lodžií konštrukčného systému ZT bolo vypracované v rámci Vedecko-technického projektu (VTP) 2811001800, etapy 02.1 „Pilotný projekt obnovy bytovej výstavby“. V spolupráci so spoločenstvom vlastníkov a správcom PROGRES, s.r.o. sa na overenie vybral bytový dom na Novohorskej ulici č. 12-20 v Bratislave. Cieľom realizácie pilotného projektu bolo potvrdenie príčiny vzniku poruchy a stanovenie nákladov na jej odstránenie.

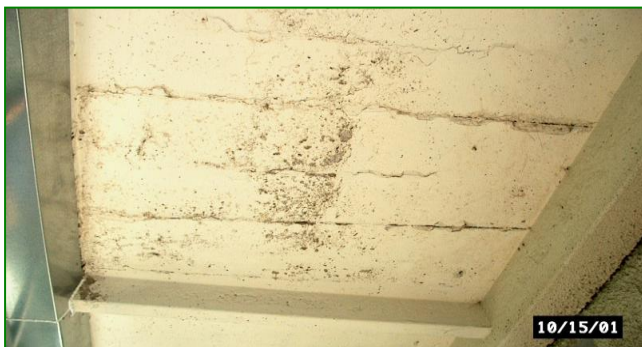
- A. Technický stav zábradlia lodžií bol vyhovujúci, korózia sa vyskytovala len ojedinele a v počiatočnom štádiu.
- B. Po celom vonkajšom povrchu obvodovej steny oboch priečelí (pred celou stenou mimo schodísk sú predstavené lodžie) steká atmosférická voda, ktorá v mnohých prípadoch (v rozsahu približne 45%) zateká aj do bytov. Na západnom priečelí bolo zatekanie intenzívnejšie (smer prevládajúcich vetrov).
- C. V stropných paneloch lodžií sa zistili trhliny a korózia výstuže (v rozsahu približne 80%).

Trhliny a korózia výstuže v stropnej lodžiovej doske
Cracks and corrosion of reinforcement in a ceiling loggia board

- A. The technical shape of the loggia railings was suitable, the corrosion occurred only sporadically in an initial stage.
- B. Along the external surface of the outer wall of both façades (the loggias protrude from the entire wall except where the staircases are located) atmospheric water flows that in many cases leaks into the apartments (in a range of approximately 45%). On the western façade the leakage had been more intensive (predominant direction of wind).
- C. Cracks and corrosion of reinforcement were identified in the ceiling panels of the loggias (approxim. 80%).

Pôvodné projektové riešenie predpokladalo napojenie navrhovaného sanačného systému na jestvujúci hydroizolačný systém lodžiovej dosky. Pri realizácii sa zistilo, že na lodžiách **nebola zrealizovaná žiadna hydroizolačná vrstva** v podlahových vrstvách a preto sa v plnom rozsahu odstránili všetky podlahové vrstvy až na nosnú časť lodžiovej dosky. Po očistení a ošetrení skorodovanej výstuže sa naniesla minerálna ochrana proti korózii – ASOCRET-P/KS.

Oprava zdegradovaného betónu sa vykonala reprofilačným systémom Schomburg ASOCRET – P/FM30 pri náhrade prierezu od 5 do 40 mm. Pri väčšej náhrade prierezu sa použil ASOCRET – P/GM100.

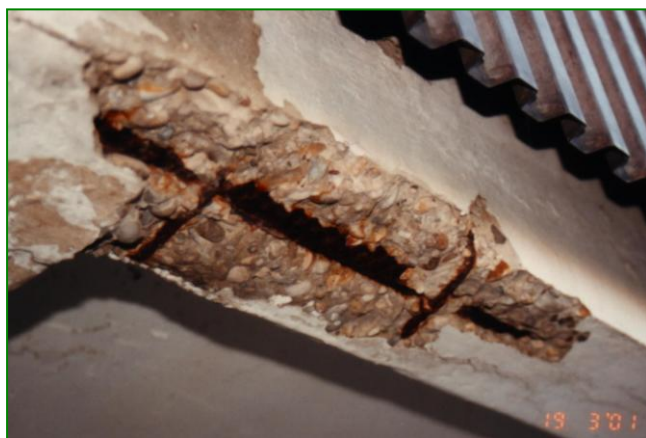
- D. V miestach stykov stropných panelov a sien lodžií boli zistené trhliny a odpadnuté kusy zdegradovaného betónu (v rozsahu asi 60%).
- E. V podlahových vrstvách nebola zhotovená hydroizolácia.
- F. Lodžia Novohorská č. 14, byt č. 11 (v prízemí východného priečelia) je uzavretá parapetným vymurovaným pásom a oknami. Priehyb stropnej dosky je zvýšený oproti ostatným približne na dvojnásobok.

Zdegradovaný betón a skorodovaná výstuž
Degraded concrete and corroded reinforcement

- D. Cracks and fallen pieces of degraded concrete were identified at the joints of ceiling panels and loggia walls (in a range of approximately 60%).
- E. Hydro-insulation had not been laid down in the floor layers.
- F. The loggia at Novohorská no. 14, flat no. 11 (on the ground floor of the eastern façade) is closed with a parapet walled band and windows. The deflection of the ceiling board was doubly increased compared to others.

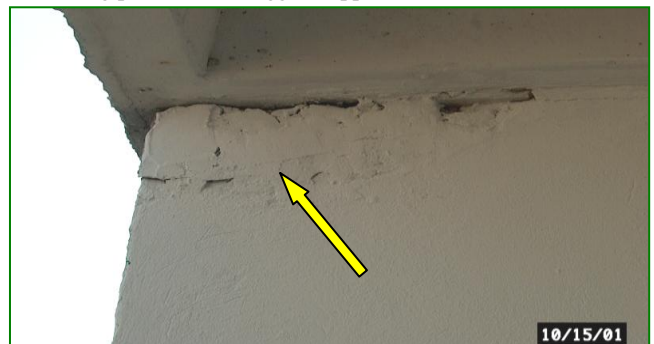
Poškodenie nosnej steny v uložení lodžiovej dosky
Damage of the bearing wall in the mounting of a loggia board

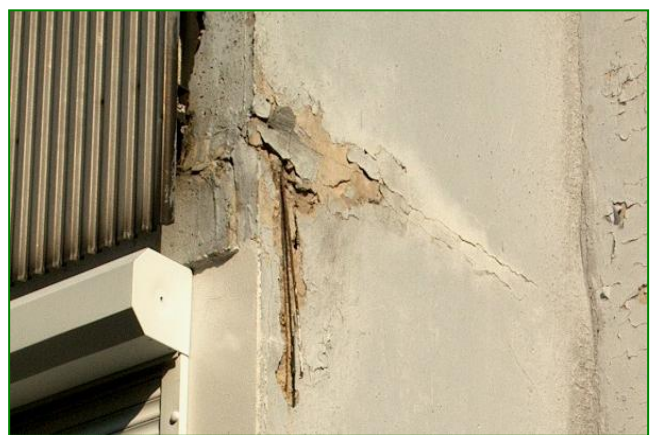
Zdegradovaná zálievka styku lodžiovej nosnej steny
Degraded filler of the joint of a loggia bearing wall

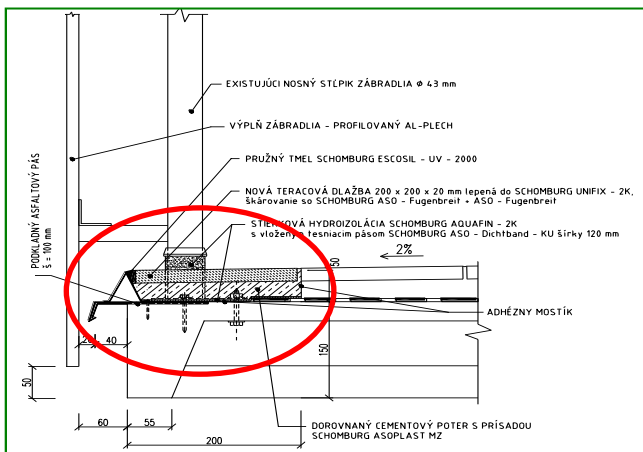
Detail koncovej úpravy lodžiovej dosky a kotvenia zábradlia
Detail of finishing of loggia board and anchoring of railing

Skorodované kotvenie zábradlia sa odstránilo a nahradilo novým kotviacim prvkom s povrchovou úpravou pozinkovaním. Výplň zábradlia bola ponechaná pôvodná z profilovaného hliníkového plechu.

Corroded railing anchoring was removed and replaced with a new anchoring element with zinc coating finishing. The railing filling was maintained with the profiled aluminium sheet.

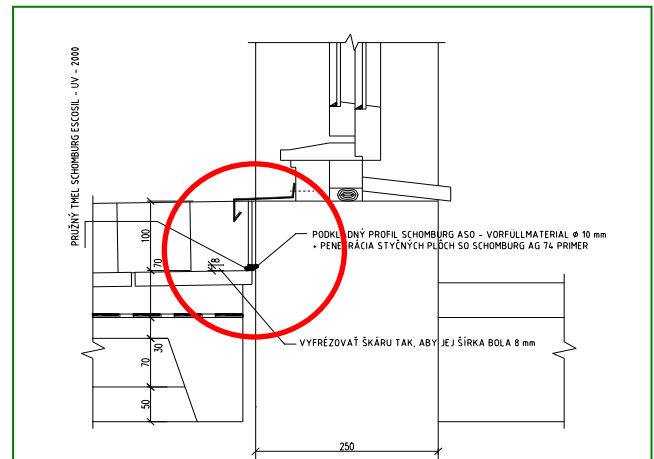
Detail úpravy keramického soklíka a dlažby
Detail of finish on ceramic plinth and flooring

Nášľapná vrstva bola vytvorená položením terazzovej dlažby lepenej do Schomburg UNIFIX – 2K a škáry boli vyplnené Schomburg ASO – Fugenbreit + ASO – FugenPlus. Vytvoril sa keramický sokel výšky 100 mm na bočných stenách.

The treading layer was formed by laying the terrazzo flooring stuck in Schomburg UNIFIX – 2K, and gaps were filled with Schomburg ASO – Fugenbreit + ASO – FugenPlus. A ceramic plinth 100 mm in height was created on the sidewalls.

Medzi keramickým soklíkom a keramickou dlažbou sa vyfrézovala škára pri obvodovom plášti tak, aby vznikla škára šírky 8 mm, ktorá sa vyplnila podkladovým profilom Schomburg ASO – VORFÜLLMATERIAL Ø 10 mm. Styčné plochy obkladu a dlažba sa napenetrovali s použitím Schomburg AG 74 PRIMER a nakoniec bola škára pretmelená pružným tmelom Schomburg ESCOSIL – UV – 200.

Between the ceramic plinth and ceramic flooring a gap was milled at the outer wall to a gap width of 8 mm, filled with bottom profile Schomburg ASO – VORFÜLLMATERIAL Ø 10 mm. The contact areas of lining and flooring were penetrated using Schomburg AG 74 PRIMER and the gap was finally sealed with Schomburg ESCOSIL – UV – 200 flexible binder.

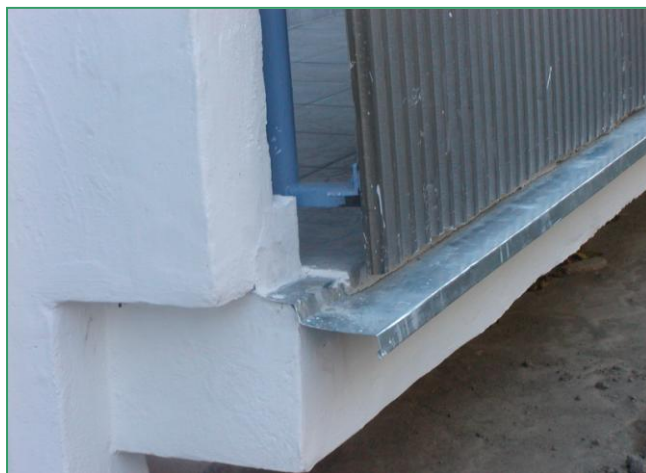
Detail lodžiovej dosky pri odkvape po obnove
Detail of loggia board at the cornice following renovation

Na opravenú lodžiovú dosku sa po osadení oplechovania celoplošne vytvoril nový hydroizolačný stierkový systém Schomburg Aquafin 2K s vytiahnutím aj na stĺpiky zábradlia a na bočné steny lodžie.

A new hydro-insulation spatula system, the Schomburg Aquafin 2K, was installed throughout the entire expanse of the repaired loggia board, extending to railing columns and loggia sidewalls.
