## PILOTNÝ PROJEKT - UL ROSNÁ Č. 3, KOŠICE

V rámci vedeckotechnického projektu VTP 6 - 400 "Obnova budov pozemných stavieb s dôrazom na bytový fond" sa riešil **pilotný projekt** Košice, Rosná ul. č. 3 zameraný na odstránenie systémovej poruchy (neskoršie zavedenej ako systémová porucha) a zníženie spotreby tepla pri prevádzke budovy.

In frame of the Research and Technology Project 6 - 400 "Rehabilitation of Ground Surface Buildings with Emphasis Put on the Housing Stock" we have developed the solution of the **Pilote Project** Košice, Rosná Str. No.3, aimed at removal of failures in the building systematic defects and on reduction of heat consumption by using of buildings.

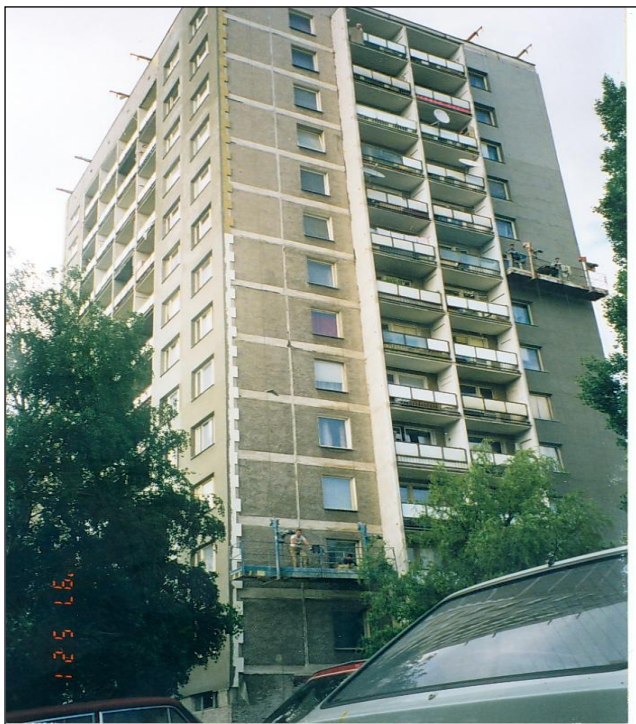
Pôvodný stav bytového domu  
Original Condition of Residential House

- dochádzalo k oddeľovaniu obkladového panela z troskopemzobetónu od nosnej štítovej železobetónovej steny.

- there came to separation of lining of slag-pemza concrete panels from the load-bearing gable

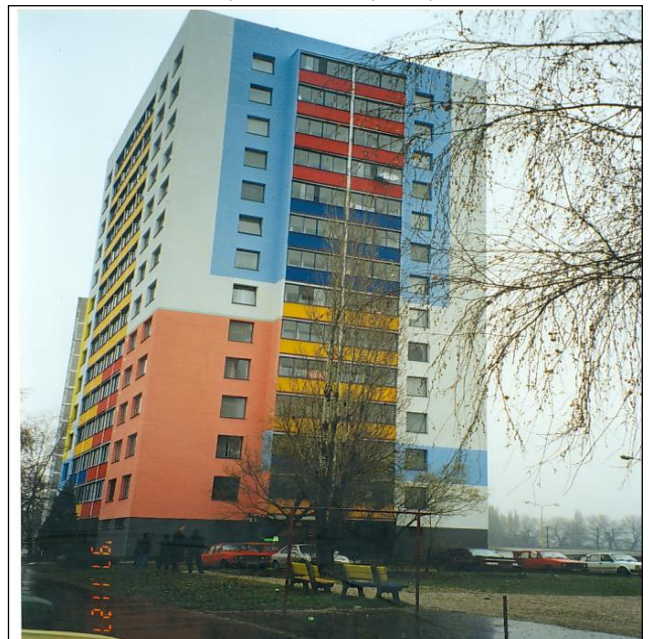
Nový stav bytového domu  
Condition of the Building after Refurbishment

Obvodový plášť bol zateplený kontaktným zateplovacím systémom GRANOLAN s tepelným izolantom PSB S20 hr. 60 mm do výšky 9. podlažia a od 10. podlažia bol penový polystyrén nahradený minerálno-vláknitými doskami NOBASIL TF ( $165 \text{ kg/m}^3$ ). Ostenia otvorových výplní sú zateplené tepelnou izoláciou hr. 20 mm a zapustené lodžie sú zateplené s tepelnou izoláciou hr. 60 mm.

The building jacket has been thermally insulated by a contact thermal insulating system GRANOLAN built from thermal insulation material PSB S20 of 60 mm thickness up to the 9<sup>th</sup> storey level and from the 10<sup>th</sup> storey upwards, the polystyrene layer has been replaced by the boards from mineral wool NOBASIL TF ( $165 \text{ kg/m}^3$ ). The sidings of the opening filling structures are thermally insulated with the thermal insulation 20 mm thick and the recessed loggias are thermally insulated with thermal insulation 60 mm thick. The ceiling in the entrance hall on the 1<sup>st</sup> storey is thermally insulated with the contact system GRANOLAN with thermal insulation 40 mm thick. The ceiling in other part of the entrance storey has been thermally insulated on the marked spots according to the project with thermal

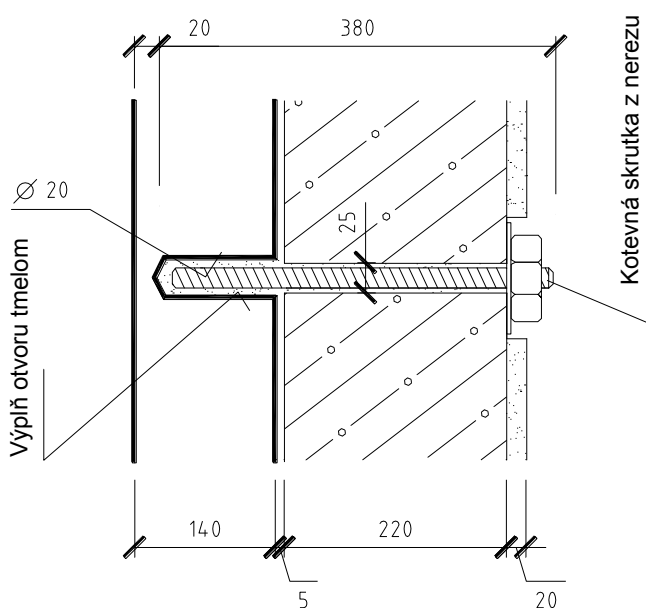
**Schema ukotvenia panelu  
Schematic View of Lining Panel Anchoring System**

**Systémová porucha** bola odstránená dodatočným ukotvením štítových obkladových panelov. Každý panel bol ukotvený 4 kotvami. Rozmiestnenie kotiev bolo navrhnuté s ohľadom na rozvody elektroinštalácie. Ukotvenie bolo navrhnuté pomocou lepených kotiev (závitová tyč  $\varnothing 16 \text{ mm}$  pozinkovaná alebo nerezová) do nosných stenových panelov vo vodorovnej polohe. Cez obkladový panel sa do hĺbky 100 mm v nosnom paneli

vyvítal otvor  $\varnothing$  22 mm. Prekontrolovala sa hĺbka vrtu a narezala sa príslušná dĺžka závitovej tyče ( dĺžky 355 - 370 mm ). Po dôkladnom vyčistení sa otvor vyplnil tmelom HILTI HIT - HY 150 a krúživým pohybom bola zasunutá závitová tyč. Vytlačený tmel sa odstránil. Po zatvrdnutí a osadení podložky R18 sa utiahla matica M16. Počas realizácie ukotvenia sa nevyskytli podstatné problémy. Zhotovené kotvy pri skúškach vykazovali značnú rezervu a sú vhodné pre aplikáciu pri odstraňovaní statických porúch, kde vzniká potreba zachytiť ťahové a šmykové sily.

The anchoring system has been designed with steel anchors glued by means of adhesive ( threaded rod  $\varnothing$  16 mm galvanized or stainless steel) into the load-bearing wall panels in horizontal position. The borehole of  $\varnothing$  22 mm diameter and 100 mm depth has been drilled into the load-bearing panel. The depth of the borehole has been measured and the corresponding length of threaded rod has been cut (total length of 355 - 370 mm ). After this borehole has been thoroughly cleaned, it has been filled with the sealing substance (tmel) HILTI HIT - HY 150 and the anchoring threaded rod has been inserted by moving it in a circular direction. Then the extruded sealing substance has been removed. After the substance had been hardened, the gasket R18 and the nut M16 were put on the threaded rod and the nut has been tightened. No essential problems have occurred during the implementation of the anchoring system. The tests performed on the manufactured anchors have proved that there is sufficient reserve in the mechanical strength and that the anchors are suited for application by removal of failures in building statical physics, when it is necessary to hold the tensile and torsion forces.

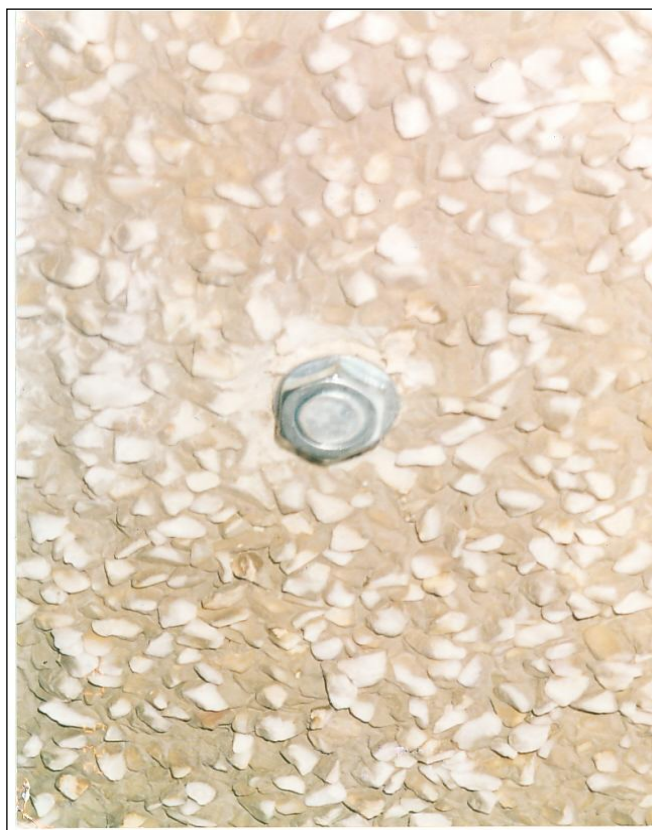
**Pohľad na zrealizované ukotvenie  
View of Implemented Anchoring System**

**The systematic failure** has been removed through supplemental mounting of additional front-side lining panels. Each panel has been mounted by means of 4 anchors. The layout of these anchors has been designed

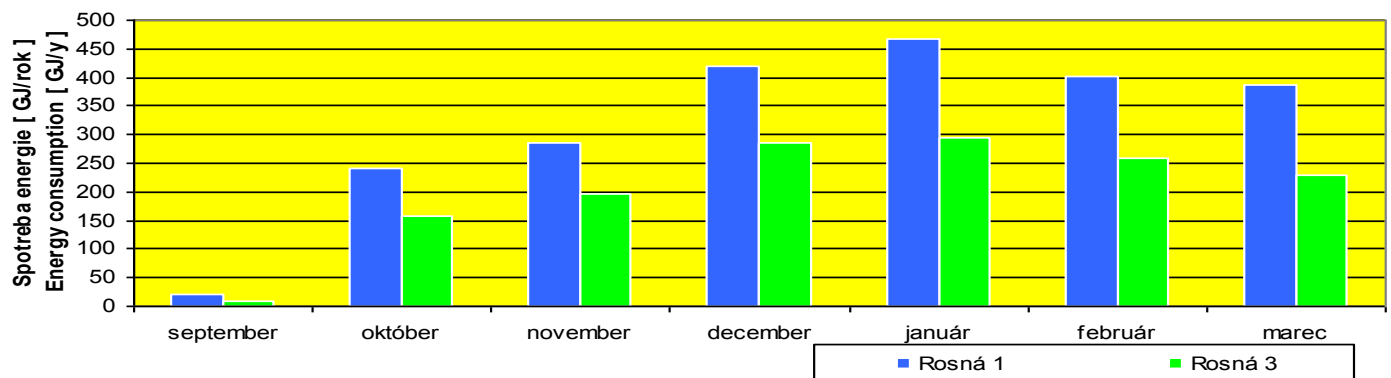
**Vyhodnotenie :** Uvedenými úpravami sa dosiahla bezpečnosť pri prevádzke domu odstránením statickej poruchy. Zlepšením stavebno-fyzikálnych parametrov obalových konštrukcií bytového domu sa v období od novembra 1996 do marca 1997 dosiahlo zníženie spotreby tepla o 20%. 40% úspora sa preukázala za vykurovacie obdobie september 1997 až marec 1998 po ukončení stavby.

Energetická spotreba za rok 1997/98

Energy consumption in year 1997/98

**Conclusion** – through above mentioned adaptations we have achieved safe operation of apartment house through removal of building statics failure and through the improvement of building-physical parameters of the building jacket of the apartment house, and from November 1996 until March 1997, the heat savings of 20%, 40% saving has been proved for the heating period September 1997 until March/1998 after completion of the refurbishment works on the building. The heat use has been reduced to  $E = 128 \text{ kWh}/(\text{m}^2 \cdot \text{year})$ , per 1 unit flat.

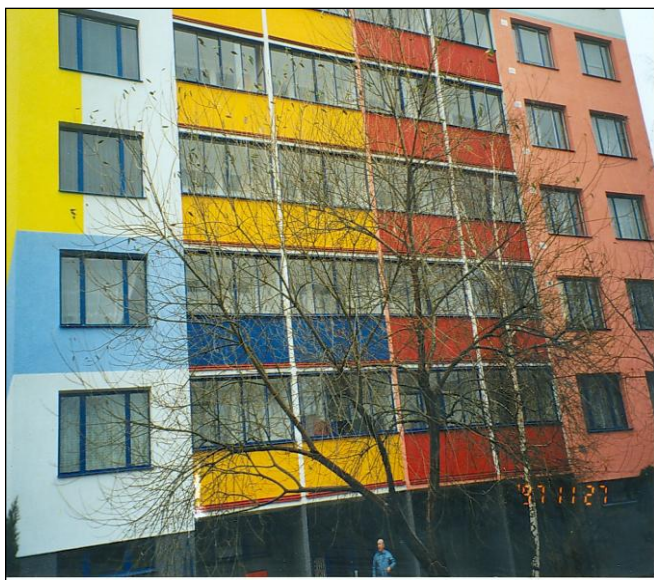
Detail nového priečelia  
Detail of the New View of the Facade
