PILOTNÝ PROJEKT ODSTRÁNENIA SYSTÉMOVEJ PORUCHY LODŽIÍ ZT

Posúdenie výskytu a návrh odstránenia systémovej poruchy predsadených lodžií konštrukčného systému ZT bolo vypracované v rámci Vedecko-technického projektu (VTP) 2811001800, etapy 02.1 „Pilotný projekt obnovy bytovej výstavby“. V spolupráci so spoločenstvom vlastníkov a správcom PROGRES, s.r.o. sa na overenie vybral bytový dom na Novohorskej ulici č. 12-20 v Bratislave. Cieľom realizácie pilotného projektu bolo potvrdenie príčiny vzniku poruchy a stanovenie nákladov na jej odstránenie.

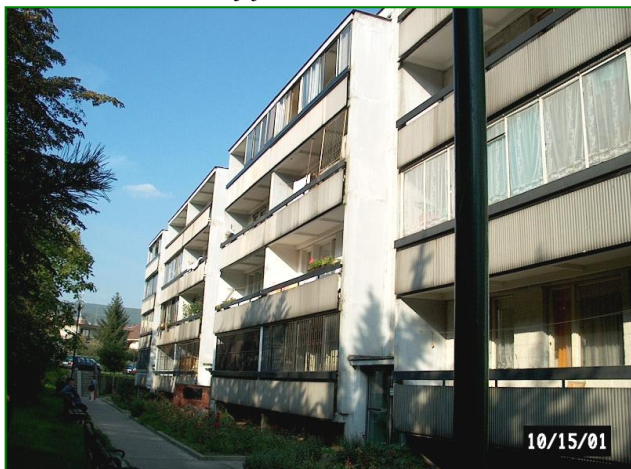
▲
Pohľad na čelnú fasádu bytového domu – pôvodný stav
View of the front façade of the apartment building – original condition.

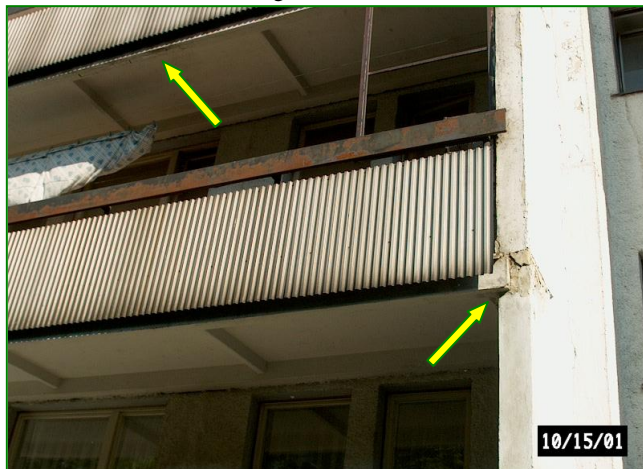
▲
Pohľad na predsadenú lodžiu – pôvodný stav
View of protruding loggia - original condition

- A. Technický stav zábradlia lodžií bol vyhovujúci, korózia sa vyskytovala len ojedinele a v počiatočnom štádiu.
- B. Po celom vonkajšom povrchu obvodovej steny oboch priečelí (pred celou stenou mimo schodísk sú predstavené lodžie) steká atmosférická voda, ktorá v mnohých prípadoch (v rozsahu približne 45%) zateká aj do bytov. Na západnom priečelí bolo zatekanie intenzívnejšie (smer prevládajúcich vetrov).
- C. V stropných paneloch lodžií sa zistili trhliny a korózia výstuže (v rozsahu približne 80%).

- A. The technical shape of the loggia railings was suitable, the corrosion occurred only sporadically in an initial stage.
- B. Along the external surface of the outer wall of both façades (the loggias protrude from the entire wall except where the staircases are located) atmospheric water flows that in many cases leaks into the apartments (in a range of approximately 45%). On the western façade the leakage had been more intensive (predominant direction of wind).
- C. Cracks and corrosion of reinforcement were identified in the ceiling panels of the loggias (approxim. 80%).

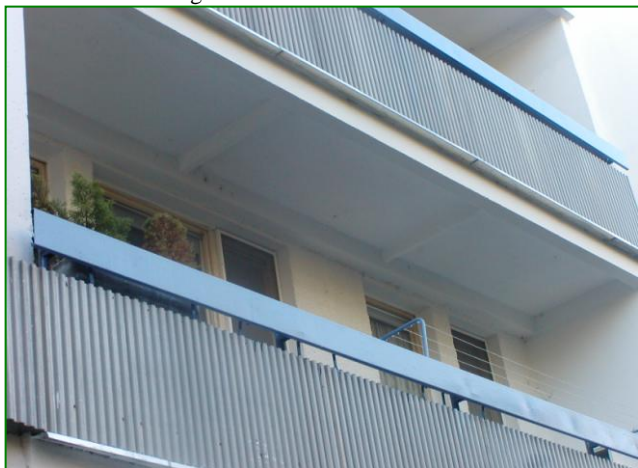
Pohľad na obnovenú lodžiu
View of the upgraded loggia

Na opravenú lodžiovú dosku sa po osadení oplechovania celoplošne vytvoril nový hydroizolačný stierkový systém Schomburg Aquafin 2K s vytiahnutím aj na stĺpiky zábradlia a na bočné steny lodžie.

Nášľapná vrstva bola vytvorená položením terazzovej dlažby lepenej do Schomburg UNIFIX – 2K a škáry boli vyplnené Schomburg ASO – Fugenbreit + ASO – FugenPlus. Vytvoril sa keramický sokel výšky 100 mm na bočných stenách.

A new hydro-insulation spatula system, the Schomburg Aquafin 2K, was installed throughout the entire expanse of the repaired loggia board, extending to railing columns and loggia sidewalls.

The treading layer was formed by laying the terrazzo flooring stuck in Schomburg UNIFIX – 2K, and gaps were filled with Schomburg ASO – Fugenbreit + ASO – FugenPlus. A ceramic plinth 100 mm in height was created on the sidewalls.

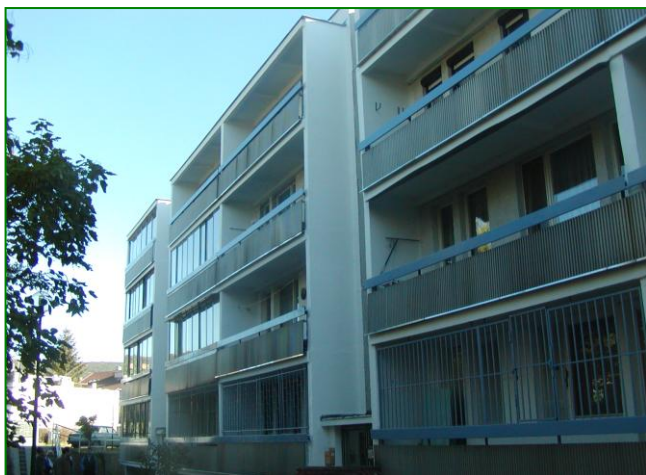
Celkový pohľad na fasádu s obnovenými lodžiami
Overall view of façade with upgraded loggias

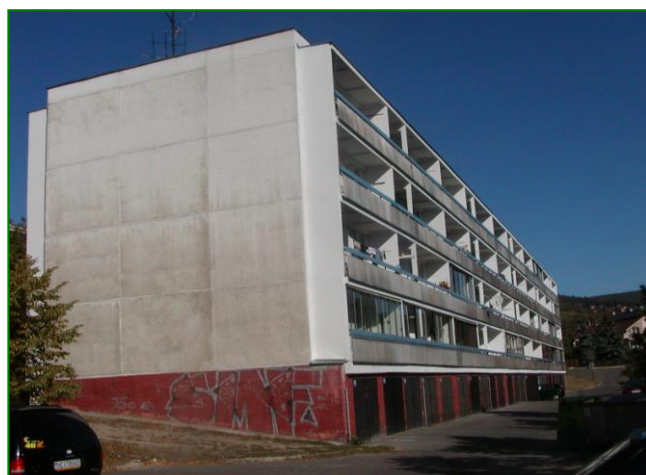
Celkový pohľad na fasádu s obnovenými lodžiami
Overall view of façade with upgraded loggias
